Company : Thai Honda Manufacturing , motorcycles

Thai Honda , has operated in Bangkok , Thailand since 1965 , manufacturing automobiles , motorcycles & power tools for the Asian market

A series of 220 kw air compressors and air dryers generating compressed air which is used to power various equipment through out the plant . Due to the energy produced the equipment generates a large amount of heat and cooling water is continuously circulated through the equipment to control the temperature.

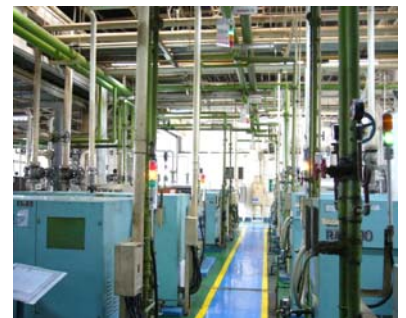
Above : Feed line to Compressors with scale deposition

Despite a costly softening and chemical dosing system treating the water before it is used for cooling , pipelines and the compressors were suffering from scale deposition. The compressors required regular maintenance to remove the scale deposits and there was considerable pressure losses throughout the system due to scale build up. Once scale starts to form there is an increase in the work load of the pumps as pressure losses increase resulting in a increase in the amount of power required to pump the water round the system.

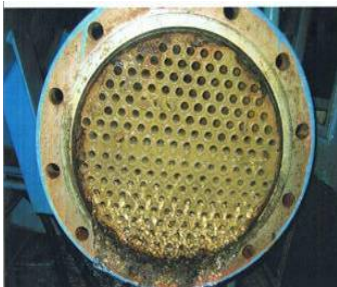
Above : Compressor after with scale.

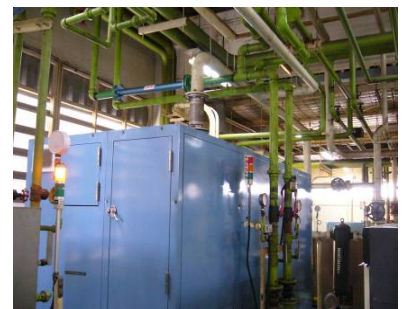
One of the compressors was chosen for the purposes of a trial to assess the performance and impact a Colloid-A-Tron would have in this system. On November 21st The Colloid-A-Tron was installed on the feed line to the compressor under supervision by Honda ,

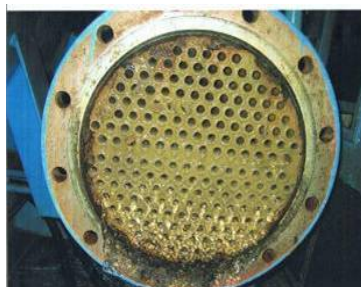
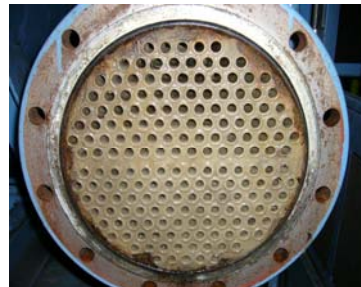
As one can see from the photo of the compressor not only has scale been prevented but existing scale has been removed returning the compressor to the desired condition in order for it to operate at maximum efficiency

The trial was due to be assessed over a 6 month period but after within four weeks the engineers had noticed remarkable improvement on the reduction of pressure losses within the system. Data had been collected before and during the trial and this was analysed and Honda produced figures showing a reduction in pressure losses from 68% down to 45%. This meant a decrease of 6.6% in power usage of the pumps.
